Re: On-Site Acoustic Assessment of Room Acoustics

Klem Acoustic Consulting (KAC) was asked to provide an on-site acoustical assessment for a room in a single-family residential dwelling. The chief concern was to assess the acoustical properties of a DIY-built mixing room in order to understand the nature of the existing space, which helps inform treatment suggestions that could improve its acoustic properties.

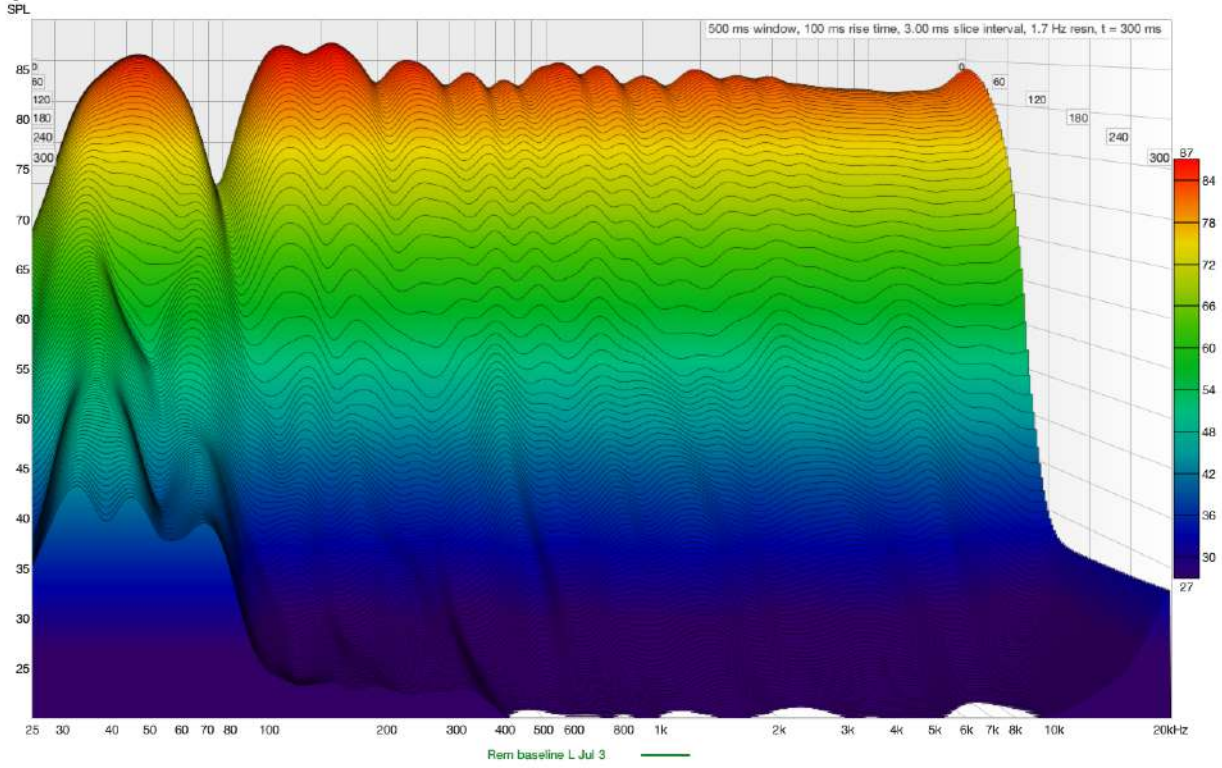
Figure 1: Waterfall from Left Speaker

The room has relatively even and smooth sound energy decay above 1kHz. Values below that show the destructive interference of sound energy reflecting back to the listening position later in time. These sounds combine to create peaks (additive) and nulls (subtractive) at any given location in the room. E.g., there is a deep (~10dB) and wide (75-150Hz) null. Also notable is the lack of sound decay below this null.

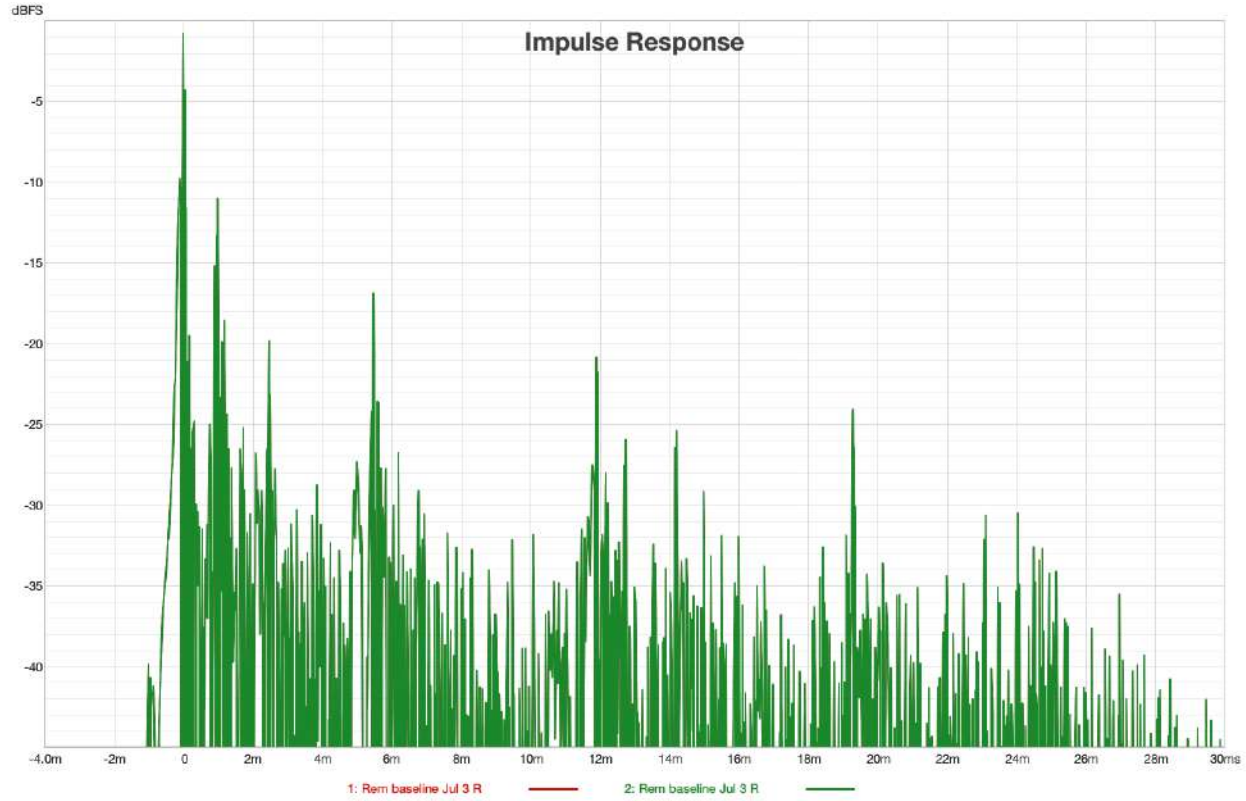
Figure 3: Impulse Response from Right Speaker

There are early reflections that interfere with and degrade the perception of music. However, the early reflections do lessen in strength with time (the decreasing peaks as you move further along the x / time axis) which helps in domains such as coherence of the stereo image.

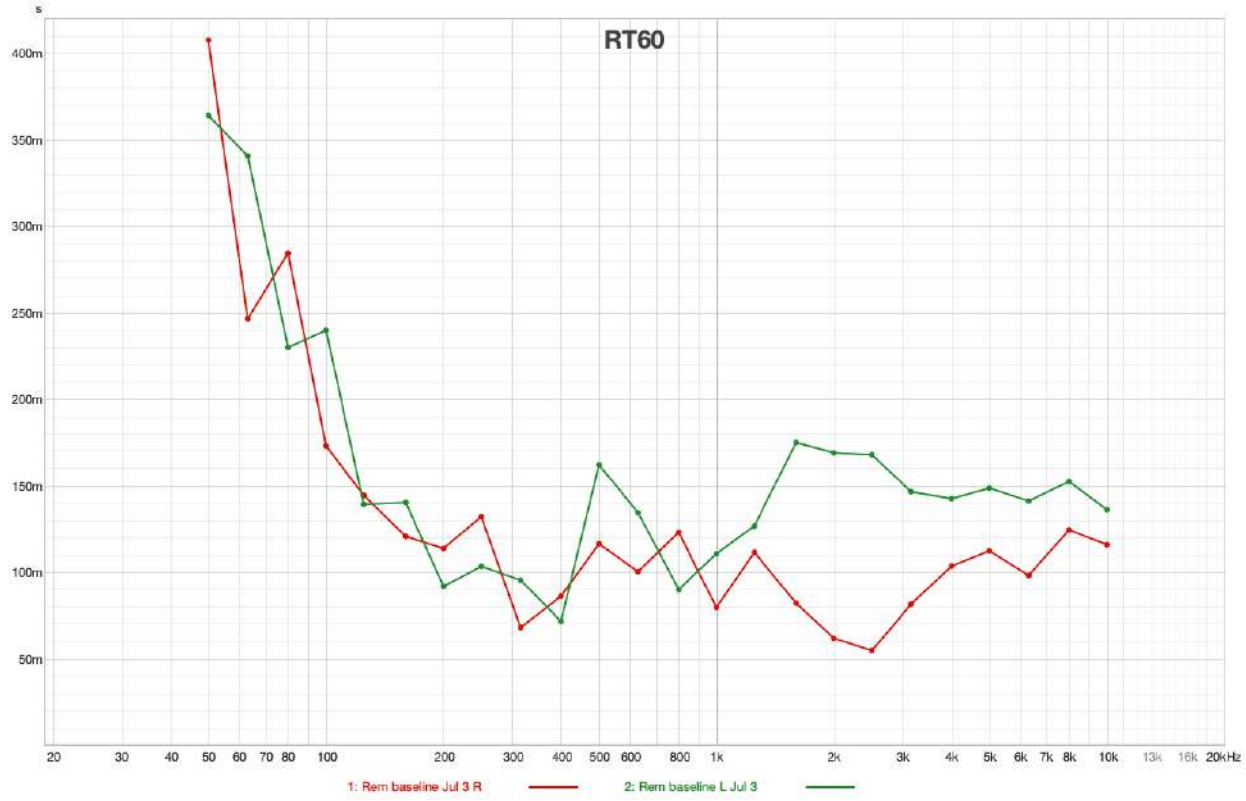
Figure 5: T30 (despite RT60 Title) from both Left and Right Speakers

T30 value is well aligned with the room's materials properties of carpet, light density fiberglass insulation and higher density felt. The mid to high frequencies are heavily absorbed with T30 values below 100ms, and then dramatically increase by a factor of up to 4 below 150 Hz. The room suffers from a build-up of low frequency energy. This is a common occurrence in small room acoustics.

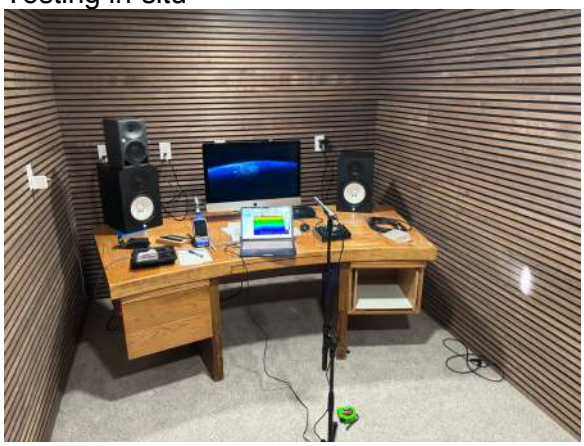
Testing in-situ
